The Aseismic Upgrading of the Structures in the “Grande Albergo” Hotel – Potenza (Italy)

Aldo Arcangeli, Antonio Costabile, Maurizio Leggeri, M.EERI

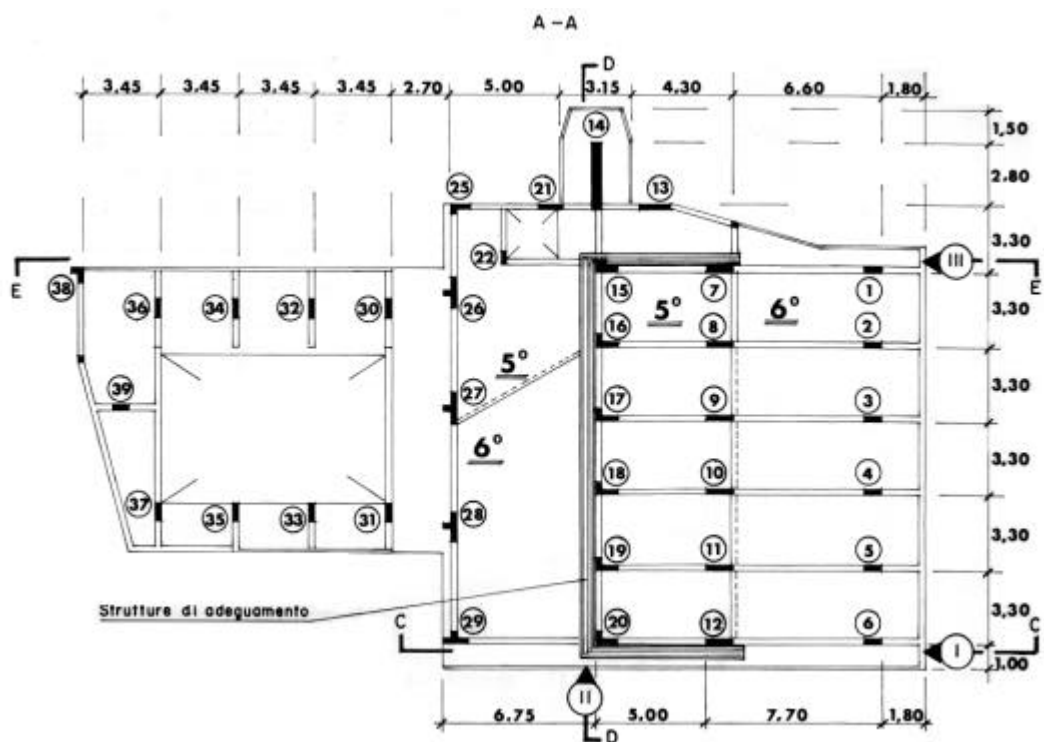
Fig. 2 : Section A – A (Plan of 5th and 6th floor Structures)

- L or T shaped, or elongated rectangular, columns, oriented in each orthogonal plan direction;
- Hollow-clay brick floor structures with an upper concrete slab, reinforced with a grid of distribution bars running at 45° with the ribbing;
- The central frame of the outside stairwell, having a total horizontal cross-section 3.00 * 0.35 m, comprises two vertical uprights and diagonal rods following the pattern of the stairflights, thus forming a stiff vertical trestle. (See fig. 2).

The vertical frame of the outside stairwell (described above) is the stiffest element in the whole frame, in the direction of the main shock. Approximate calculation led to estimate that about 85% of all horizontal forces were absorbed by it, and the study of the damages it underwent conform this :

- No cracks in the vertical uprights, where the traditional forces were counterbalanced by the loads;
- Traction cracks in the diagonal rods, they running perpendicularly to the rod's axes;
- Small cracks in the connections between uprights and rods, where substantial secondary bending stresses developed.

The minor nature of all these cracks suffices to show that the steel was not stressed beyond its elastic limit.

The connection between the stairwell trestle and the building is basically a beam coplanar with the trestle, which supported heavy alternating forces : about 22 tons per storey. The concrete easily absorbed the compression forces, while the traction forces, which generated cracking in the beam and in the adjacent floor slabs, were absorbed by the longitudinal bars. Here too, the steel was not stressed beyond its elastic limit.

Local, limited cracking was repaired by extensive application of steel plates epoxy-resin glued to the outer face of beams and columns, wherever these displayed the minimum indication of cracking. In the vertical stairwell trestle, the empty spaces between uprights and diagonal rods were filled with pours of reinforced concrete, well tied to the existing structures, so as to further increase their strength and eliminate any crack-caused weakening.
