The Aseismic Upgrading of the Structures in the “Grande Albergo” Hotel – Potenza (Italy)

Aldo Arcangeli, Antonio Costabile, Maurizio Leggeri, M.EERI

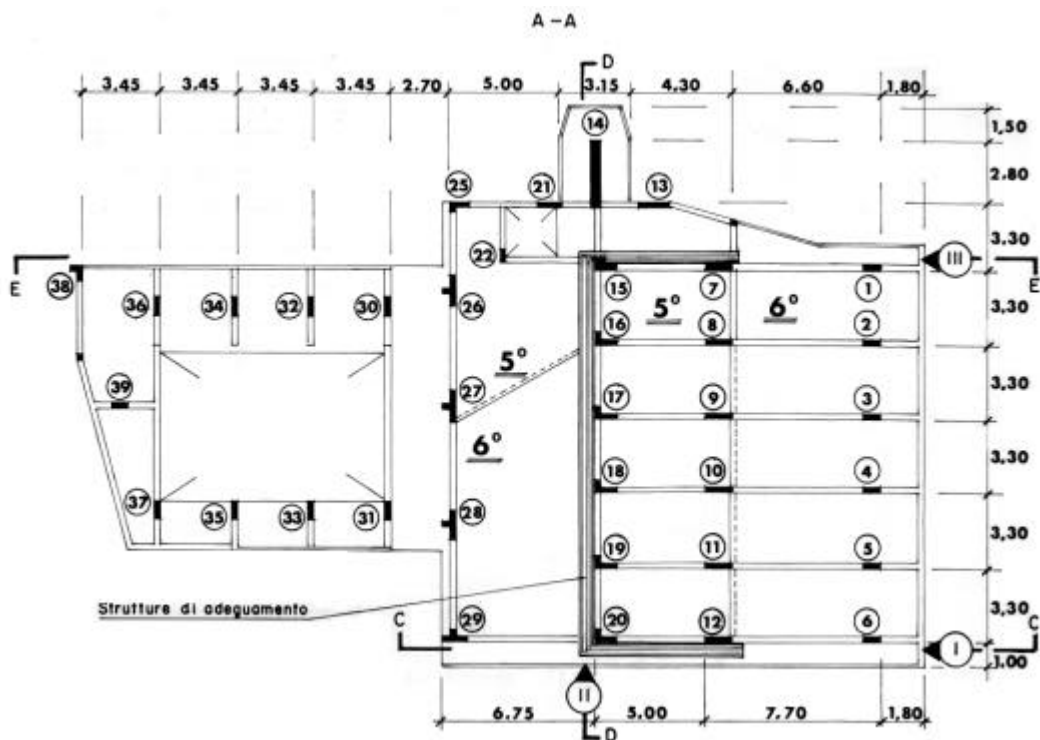
Fig. 2 : Section A – A (Plan of 5th and 6th floor Structures)

- L or T shaped, or elongated rectangular, columns, oriented in each orthogonal plan direction;
- Hollow-clay brick floor structures with an upper concrete slab, reinforced with a grid of distribution bars running at 45° with the ribbing;
- The central frame of the outside stairwell, having a total horizontal cross-section 3.00 * 0.35 m, comprises two vertical uprights and diagonal rods following the pattern of the stairflights, thus forming a stiff vertical trestle. (See fig. 2).

The vertical frame of the outside stairwell (described above) is the stiffest element in the whole frame, in the direction of the main shock. Approximate calculation led to estimate that about 85% of all horizontal forces were absorbed by it, and the study of the damages it underwent conform this :

- No cracks in the vertical uprights, where the traditional forces were counterbalanced by the loads;
- Traction cracks in the diagonal rods, they running perpendicularly to the rod's axes;
- Small cracks in the connections between uprights and rods, where substantial secondary bending stresses developed.

The minor nature of all these cracks suffices to show that the steel was not stressed beyond its elastic limit.

Local, limited cracking was repaired by extensive application of steel plates epoxy-resin glued to the outer face of beams and columns, wherever these displayed the minimum indication of cracking. In the vertical stairwell trestle, the empty spaces between uprights and diagonal rods were filled with pours of reinforced concrete, well tied to the existing structures, so as to further increase their strength and eliminate any crack-caused weakening.

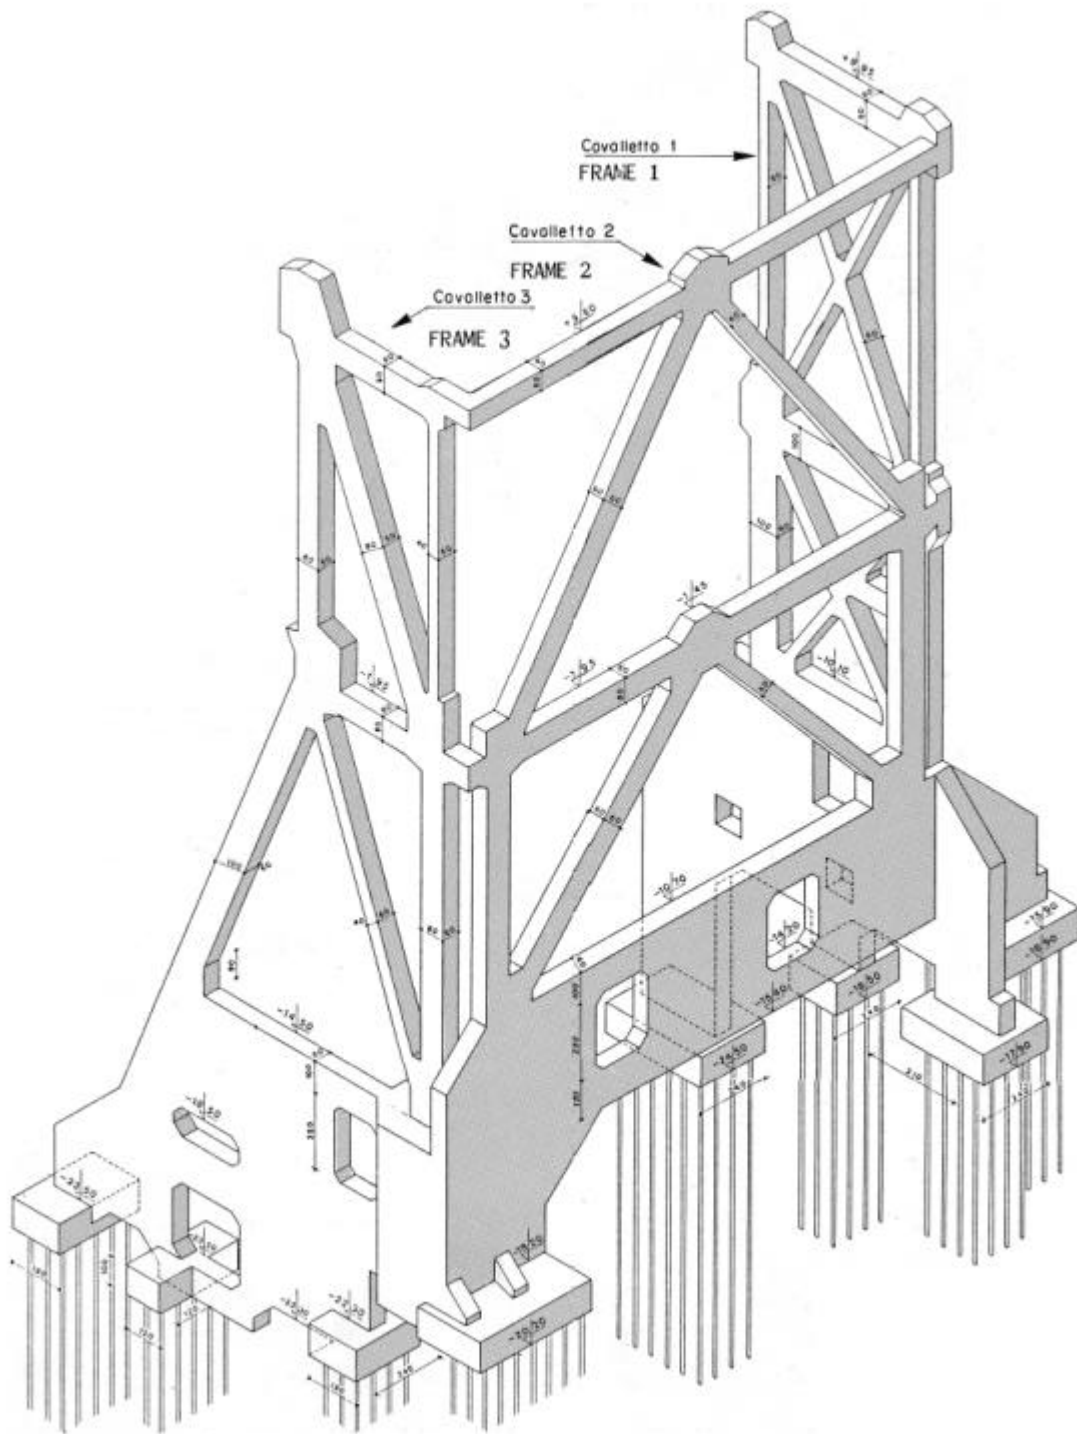
Fig. 3 : Isometric View of the new Structures

The added structures comprise three large frames (see fig. 3), solidly joined together, that essentially buttress the tower body : two crosswise, one at each end of the tower, running North-South in plan, and one central, running longitudinally East-West. They rise up better than 30 m from the foundations to the 10th storey floor structure, and are tied to the existing structure at the 2nd, 6th and 10th floors.

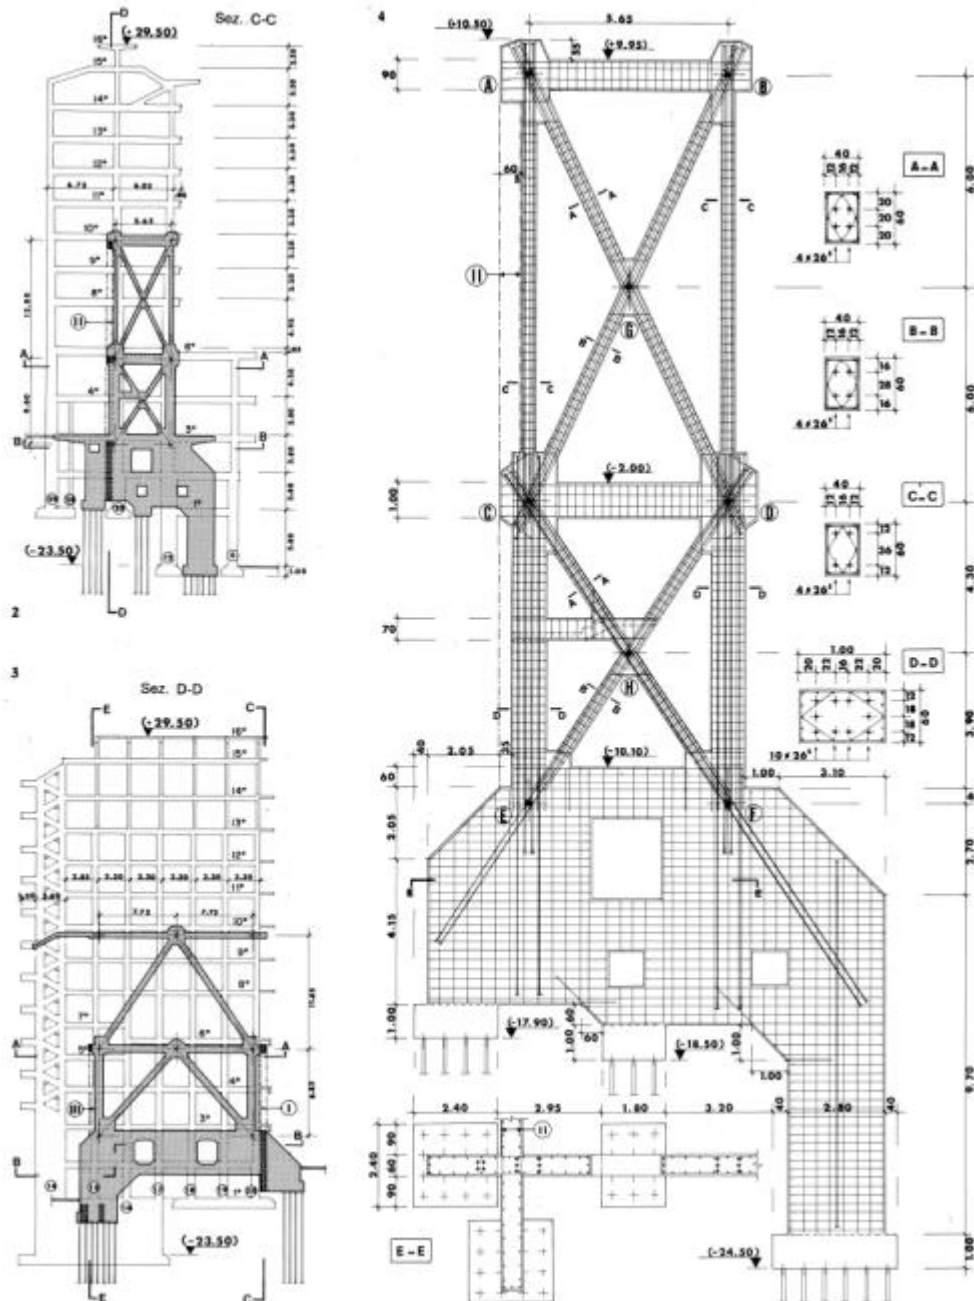
Fig. 4 : Section C-C (Frame 1)

are shaped according to a triangular grid, with constant depth of 60 cm, set 5 cm away from the adjacent old structures (see fig. 4, 5, 6). Their plane arrangement is such that the Center of Stiffness, in both normal directions, is very near the Center of Masses, so that horizontal torsional effects are cut down to the minimum.

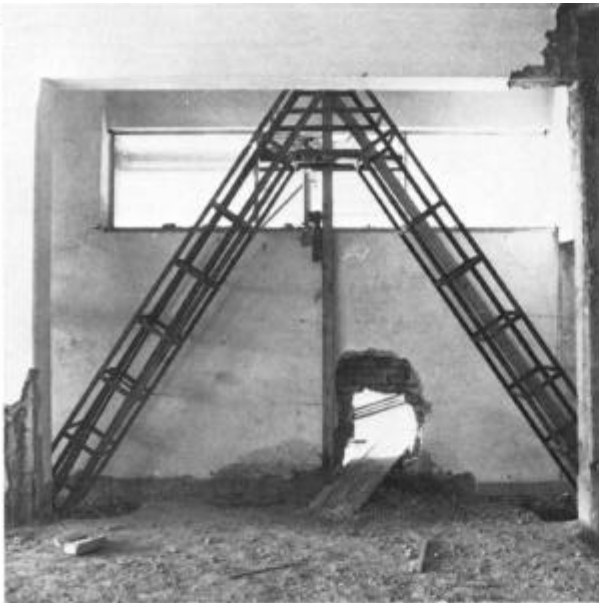
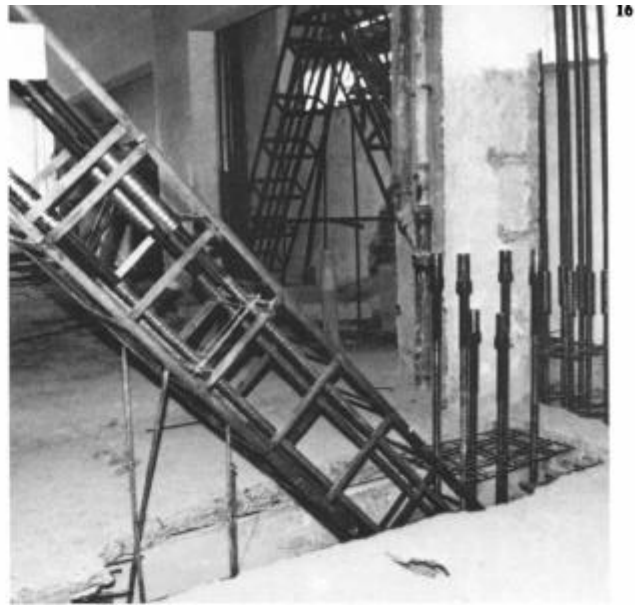
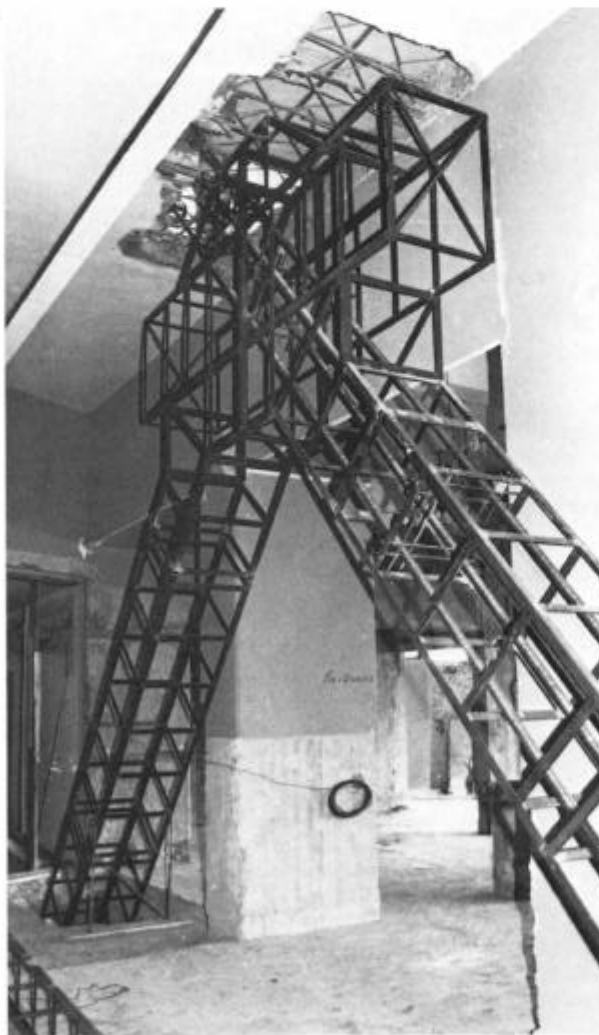
15 - Ingabbiatura di tracciamento ed armatura delle aste del cavalletto n. 1; 16 - In primo piano un'asta del cavalletto n. 2, sullo sfondo il cavalletto n. 1 e a destra, vista delle barre di precompressione con le relative giunzioni intermedie; 17 - Il cavalletto n. 2: incrocio delle ingabbiature di tracciamento in corrispondenza del nodo al quinto solaio; 18-19 - Barre di precompressione: giunzione e campane di ancoraggio; 20 - Le operazioni di tesatura delle barre di precompressione; 21 - Il piede del cavalletto n. 3 in corrispondenza del piano terra; 22 - L'inserimento della struttura di adeguamento sismico nella preesistente costruzione.

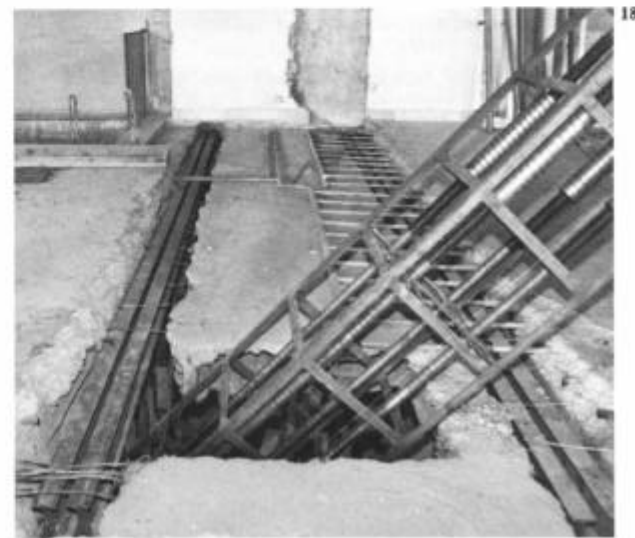
Fig. 7 : Cages made up of steel angle-irons

This difficulty was got over by first arranging cages made up of steel angle-irons that precisely defined the required profiles and permitted the exact placement of the pretensioning bars.

They were then incorporated in the pour, together with the other stirrups and longitudinal reinforcing bars (see fig. 7).
