The Aseismic Upgrading of the Structures in the “Grande Albergo” Hotel – Potenza (Italy)

Aldo Arcangeli, Antonio Costabile, Maurizio Leggeri, M.EERI

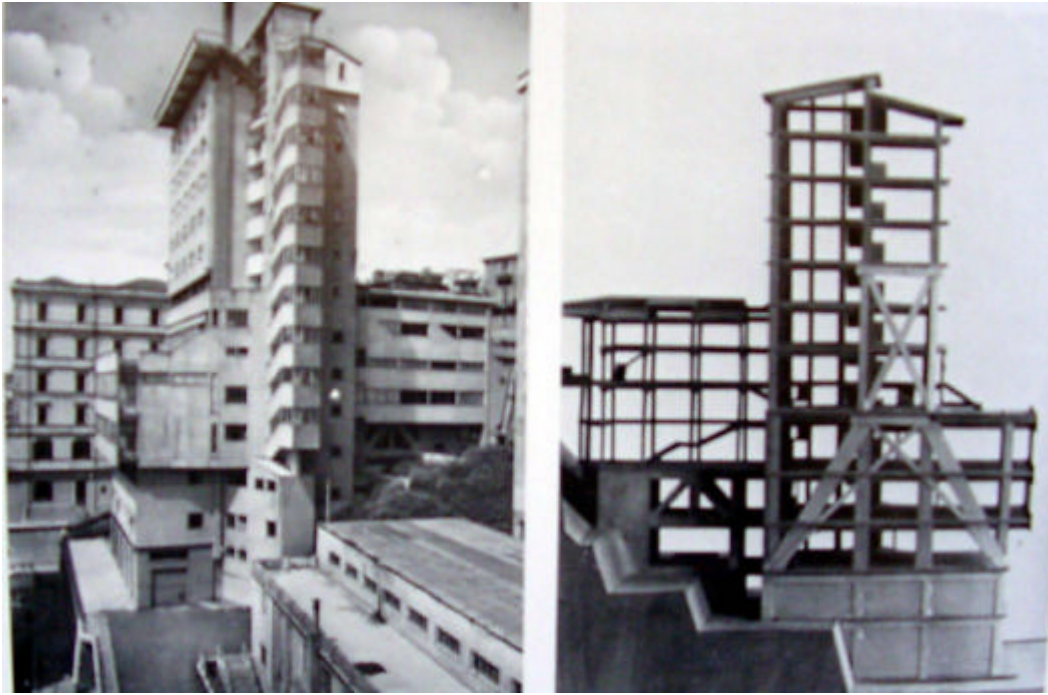
Fig. 1 : the original building (from S-E) and structural model

During the November 23, 1980 earthquake (6.8 degrees on the Richter Scale), the building took a strong shaking, the waves moving prevalently East-West. There was substantial cracking and collapse of the masonry partition walls and of the inside lining of the perimetral walls, especially in the lower storeys of the tower and those lower lying yet. But damage to structures was much lighter, having characteristics that often made it easy to discern how they had behaved statically.

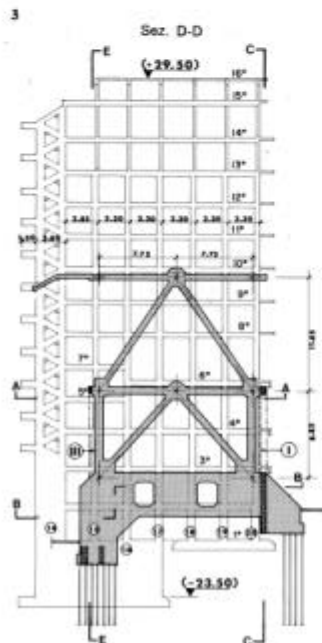
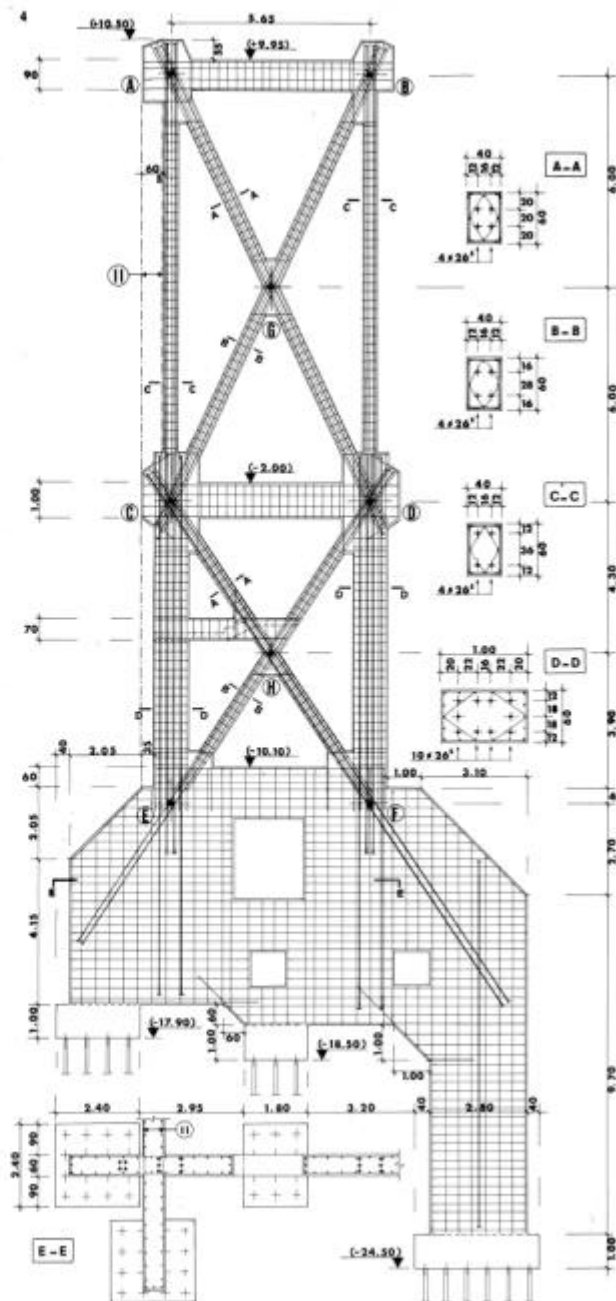
The added structures comprise three large frames (see fig. 3), solidly joined together , that essentially buttress the tower body : two crosswise, one at each end of the tower, running North-South in plan, and one central, running longitudinally East-West. They rise up better than 30 m from the foundations to the 10th storey floor structure, and are tied to the existing structure at the 2nd, 6th and 10th floors.

The lower part of the frames are made up of stiff full walls, and stand upon micro-piles foundations, which are independent of the old. Their upper areas
