The Aseismic Upgrading of the Structures in the “Grande Albergo” Hotel – Potenza (Italy)

Aldo Arcangeli, Antonio Costabile, Maurizio Leggeri, M.EERI

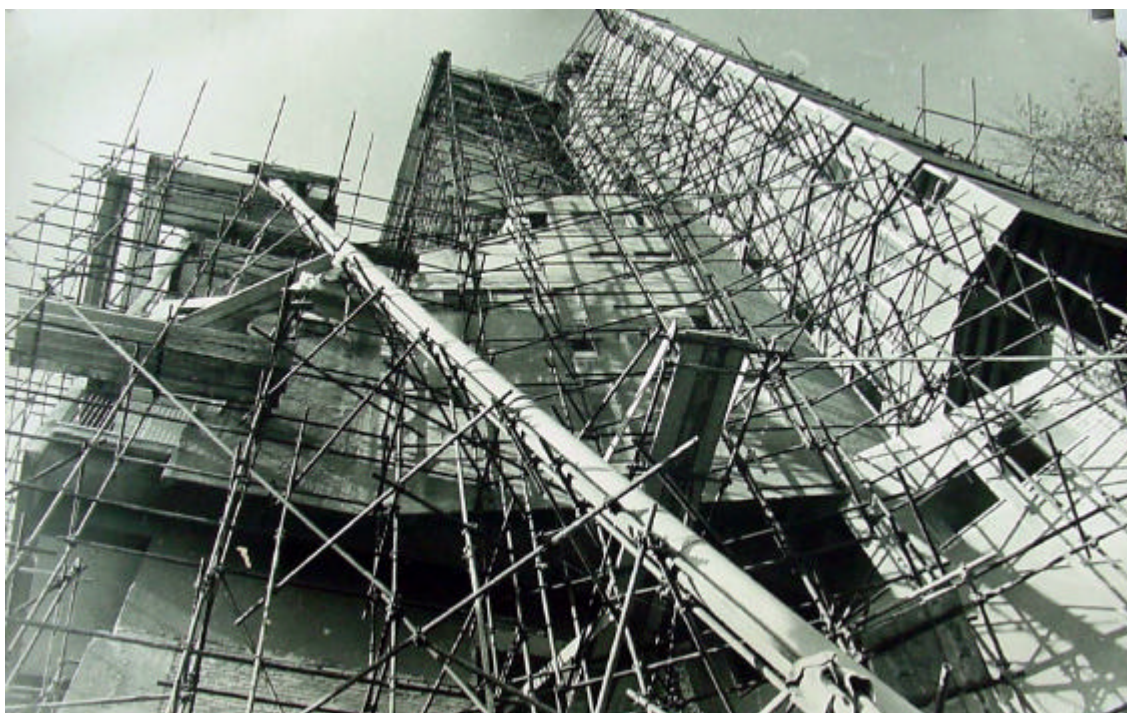
Fig. 8 - Works nearing completion

The added structures comprise three large frames (see fig. 3), solidly joined together, that essentially buttress the tower body : two crosswise, one at each end of the tower, running North-South in plan, and one central, running longitudinally East-West. They rise up better than 30 m from the foundations to the 10th storey floor structure, and are tied to the existing structure at the 2nd, 6th and 10th floors.
